**Re: Enbridge Gas Inc. ("Enbridge Gas" or "EGI")  
Ontario Energy Board ("OEB") File No. EB-2021-0148  
2022 Rates (Phase 2) Application and Evidence (Incremental Capital Module)**

This Application (EB-2021-0148) is for Phase 2 of the 2022 Rate Application and addresses matters related to 2022 ICM funding request. With this Application, Enbridge Gas is seeking OEB approval for ICM funding for five projects in 2022 – the St. Laurent Ottawa North Replacement (Phase 3) Project and NPS 20 Replacement Cherry to Bathurst Project in the EGD rate zone, and the Dawn to Cuthbert Replacement and Retrofits Project, Byron Transmission Station Project and Kirkland Lake Lateral Replacement Project in Union rate zones. The ICM evidence including the appendices are filed as Exhibit B, Tab 2, Schedule 1.

45. Enbridge Gas has identified the need to replace approximately 650 m of the existing NPS 42 Dawn to Cuthbert pipeline to mitigate pipeline integrity concerns in the Township of Dawn-Euphemia, in the County of Lambton, Ontario. The project is a like-for-like replacement of pipeline and does not require Leave to Construct approval. The NPS 42 Dawn to Cuthbert pipeline supplies the NPS 42 Dawn to

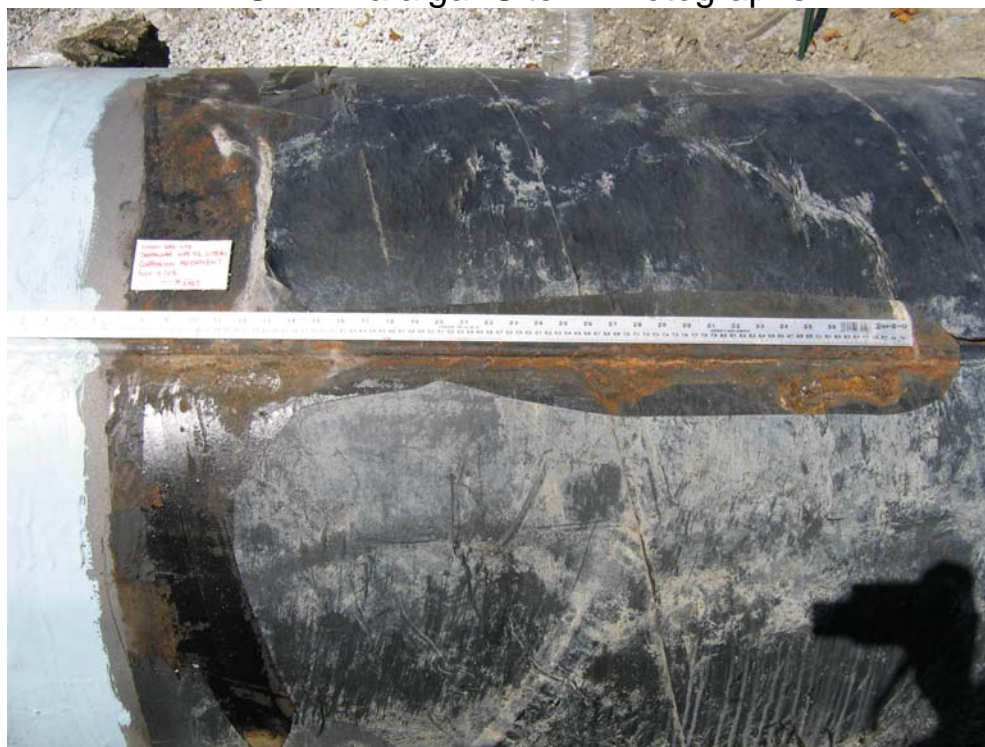
69) Corrosion Along Longseam

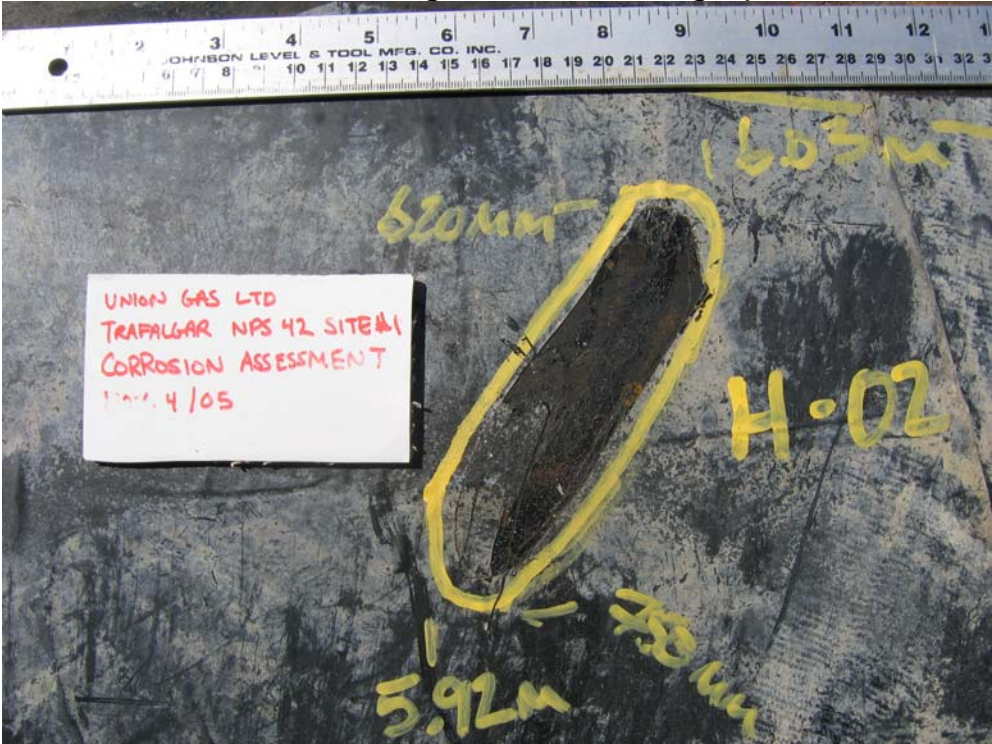
75) H-02 Corrosion

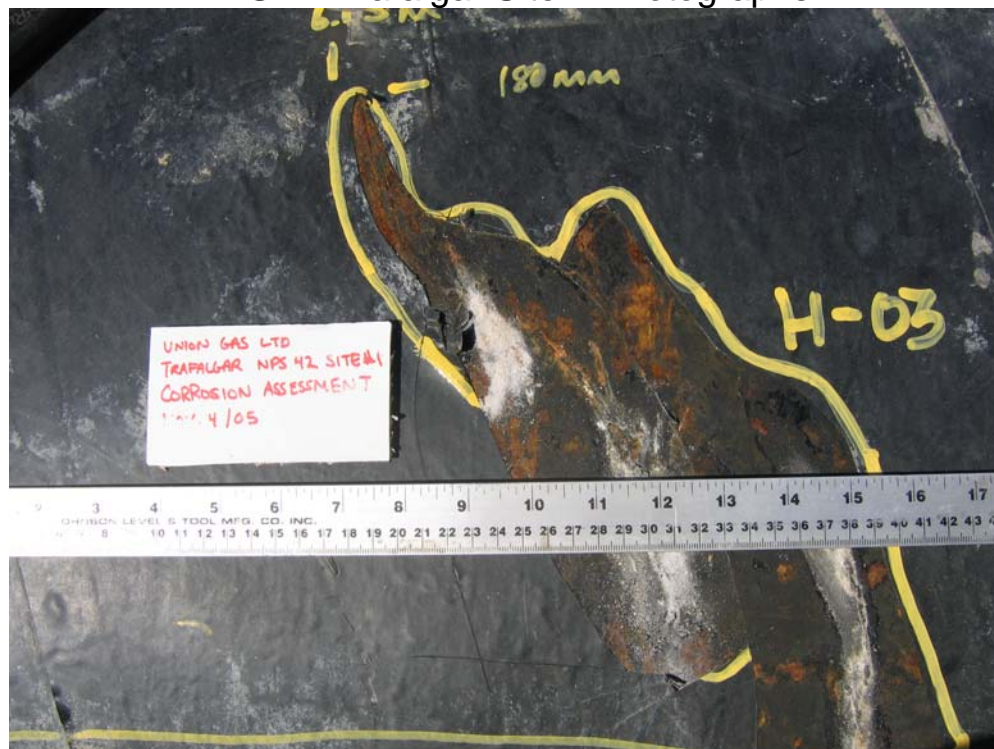
77) H-03 Corrosion and Sand

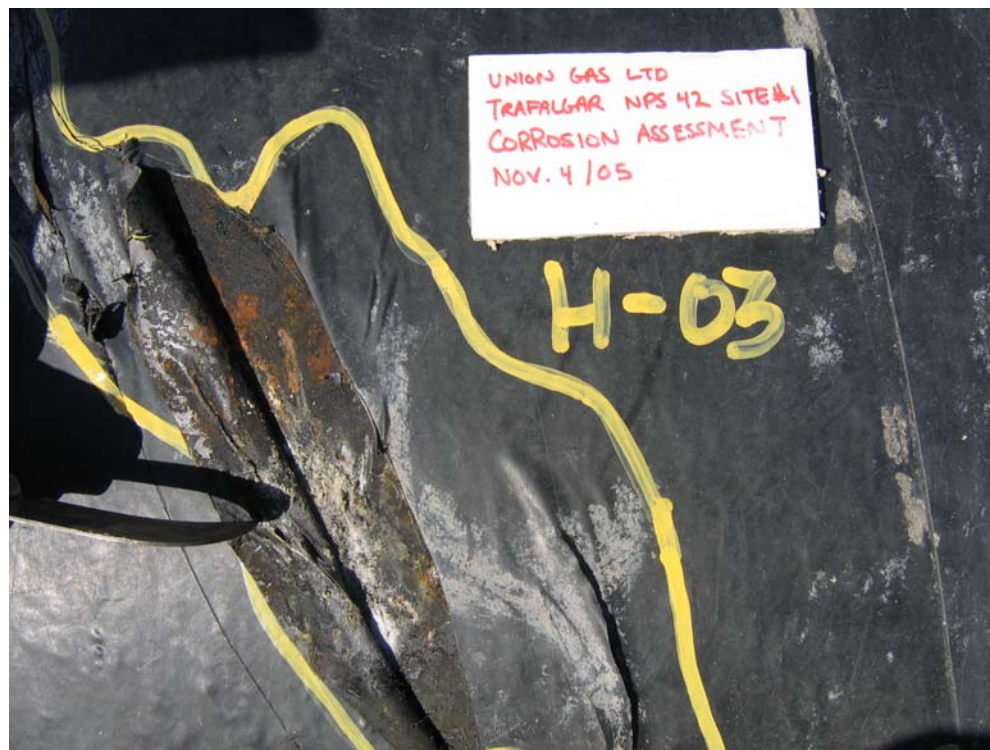
78) H-03 Corrosion Product

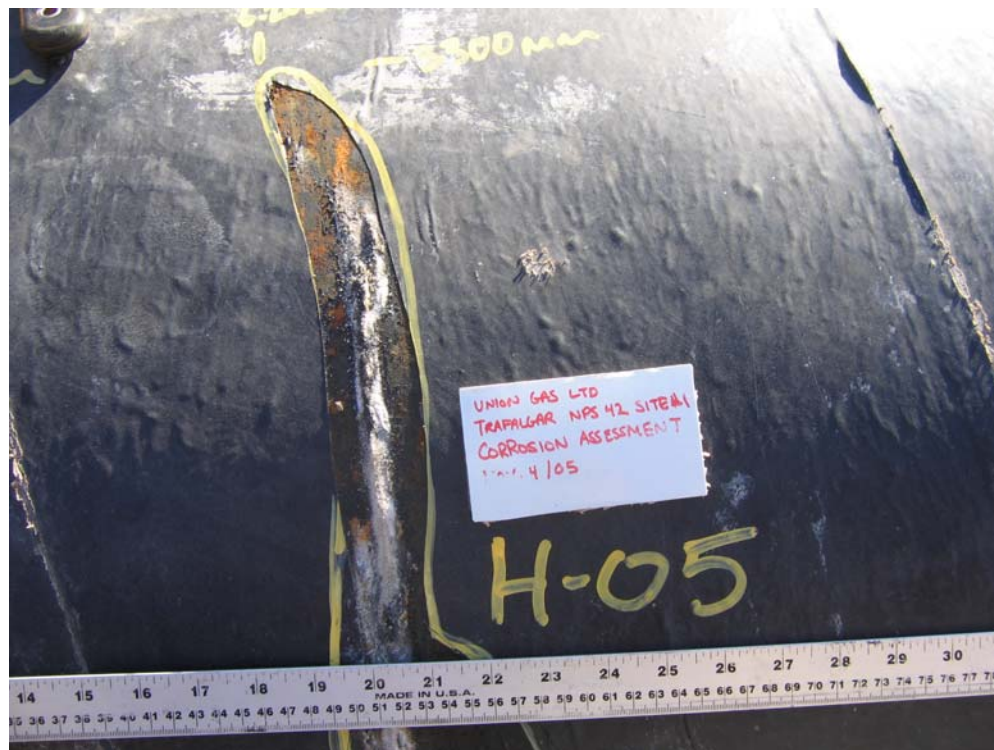
82) H-05 Corrosion and Sand  
58

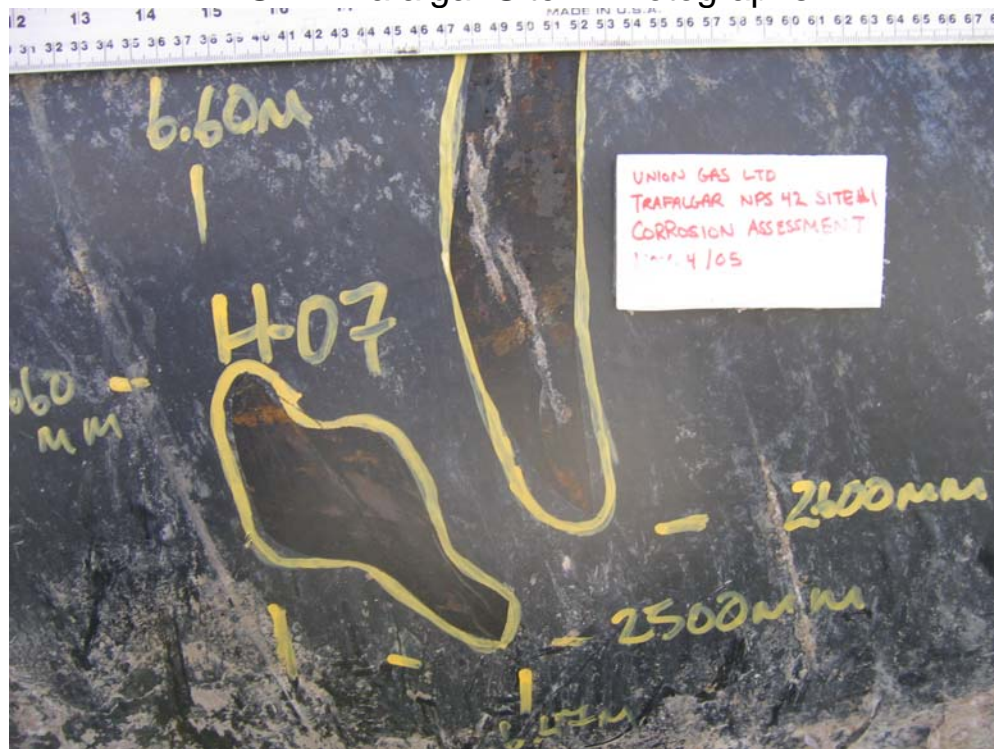
85) H-07 Corrosion

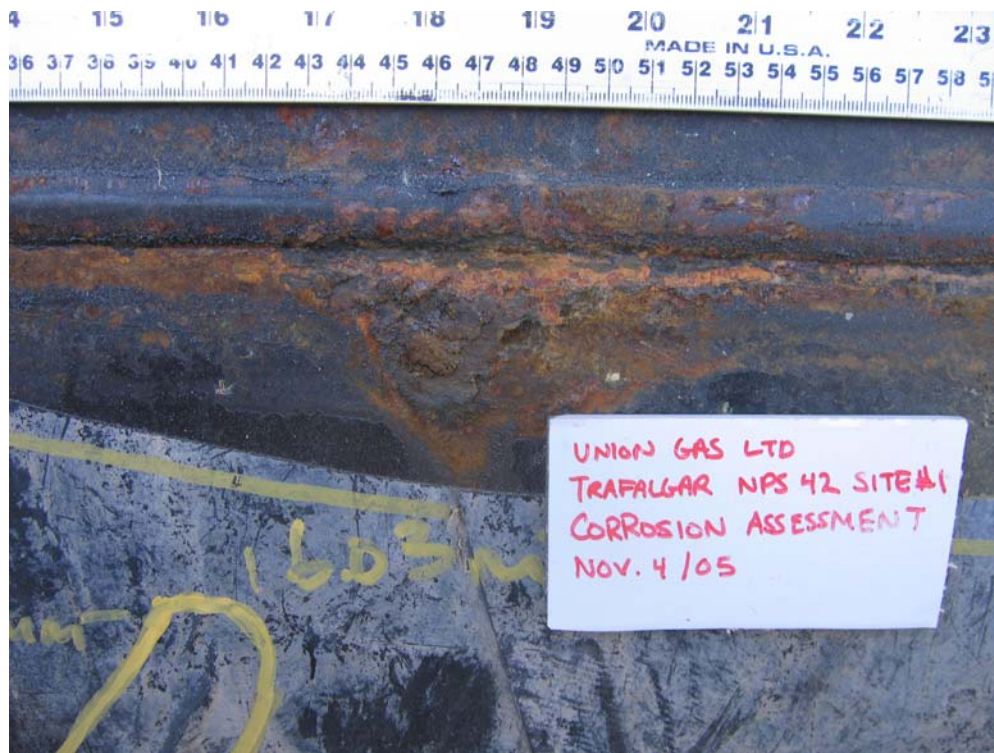
86) Longseam Corrosion

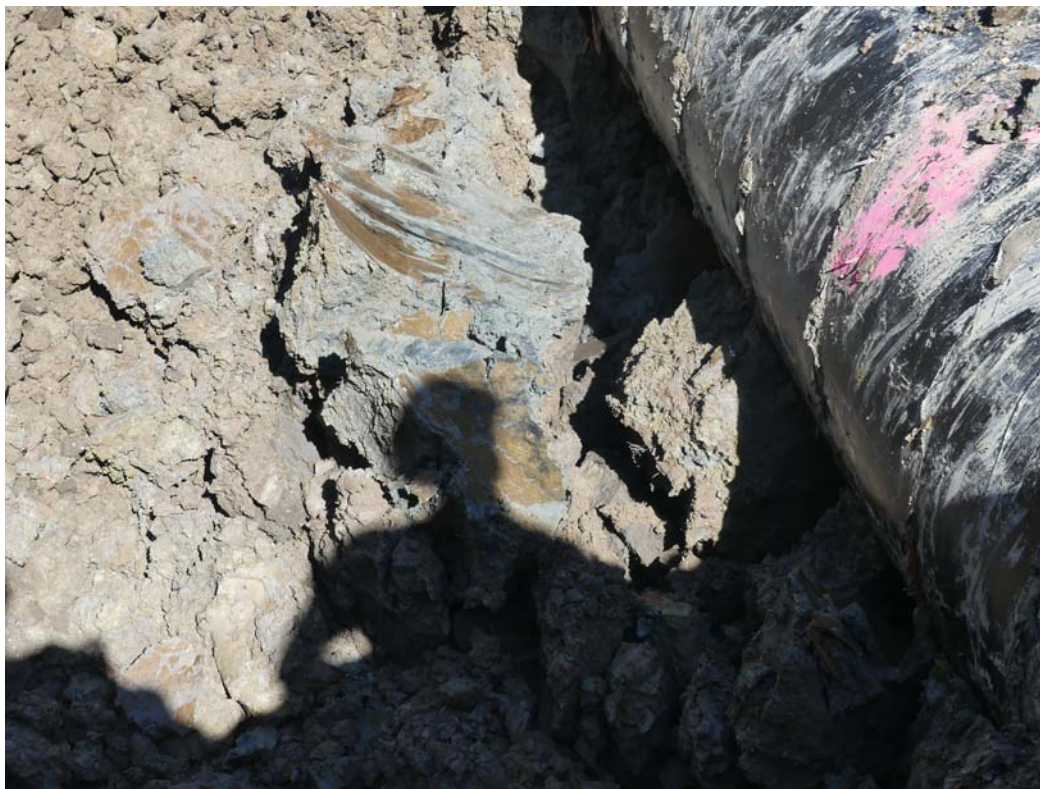
007 - STRONG GLEYING WAS FOUND AT BOTTOM OF PIPE

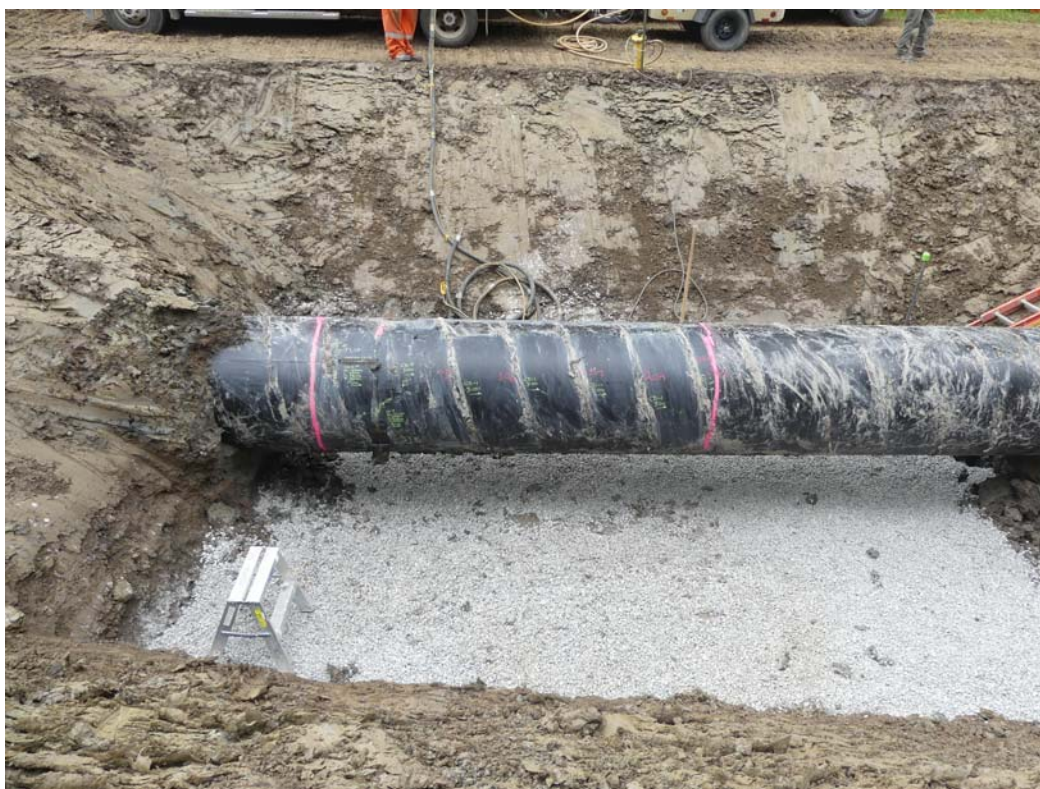
008 - COATING ASSESSMENT AREA 3 O'CLOCK SIDE

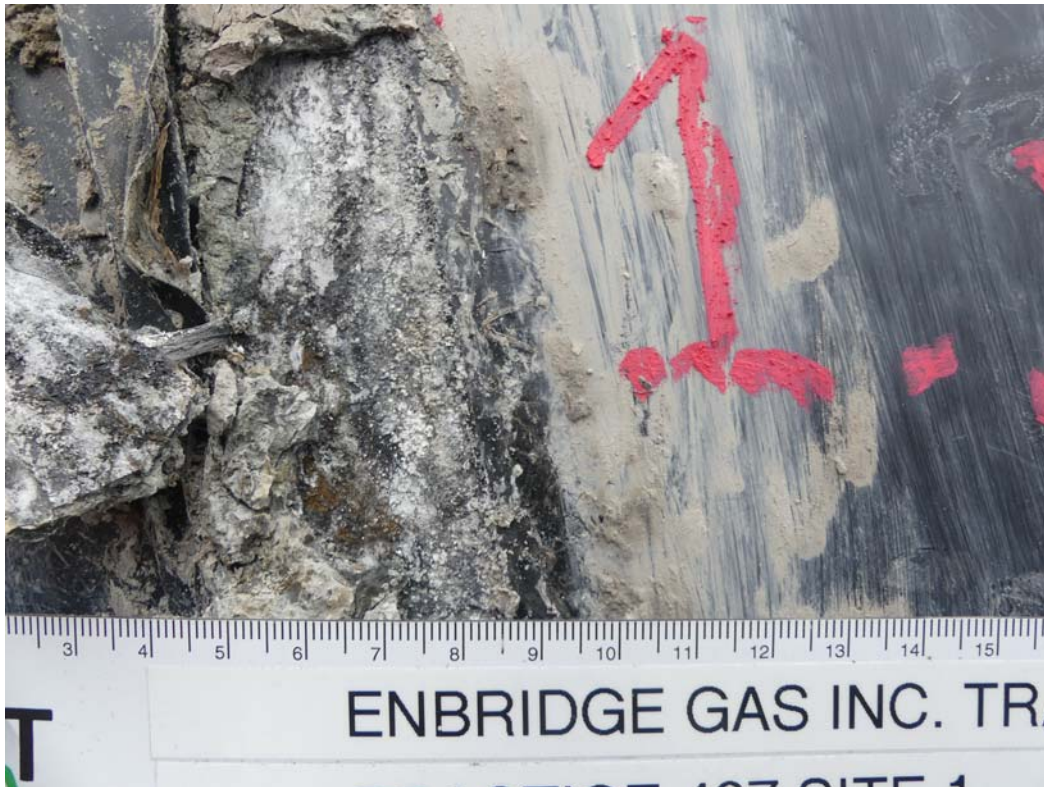
021 - CD-01 COATING REMOVED, CLOSE UP OF CORROSION DEPOSIT

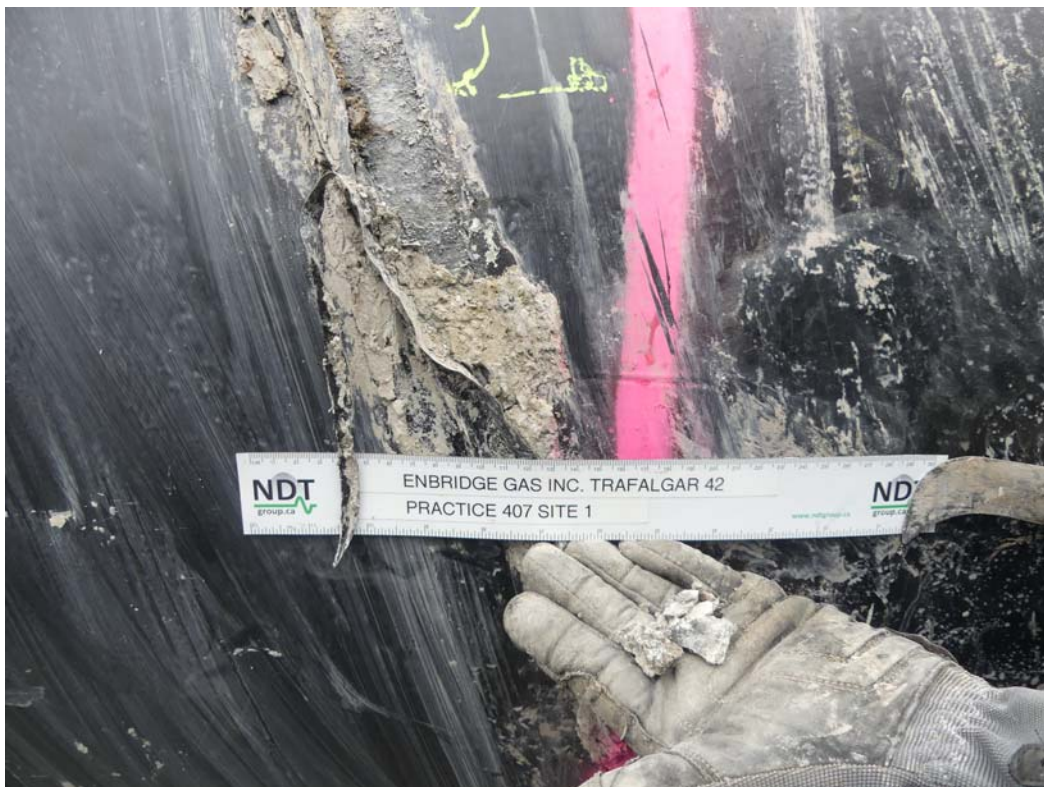
022 - CD-01 COATING REMOVED, WHITE HARD CORROSION DEPOSIT

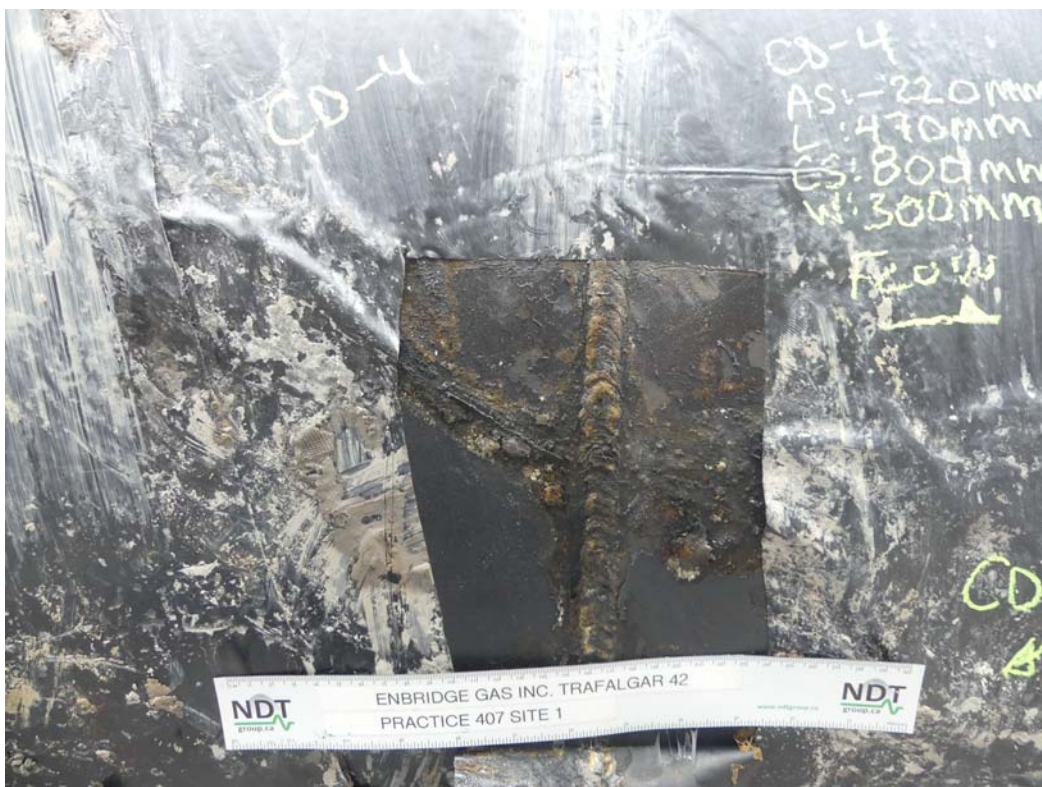
036 - CD-04 COATING REMOVED, BLACK, ORANGE CORROSION DEPOSITS

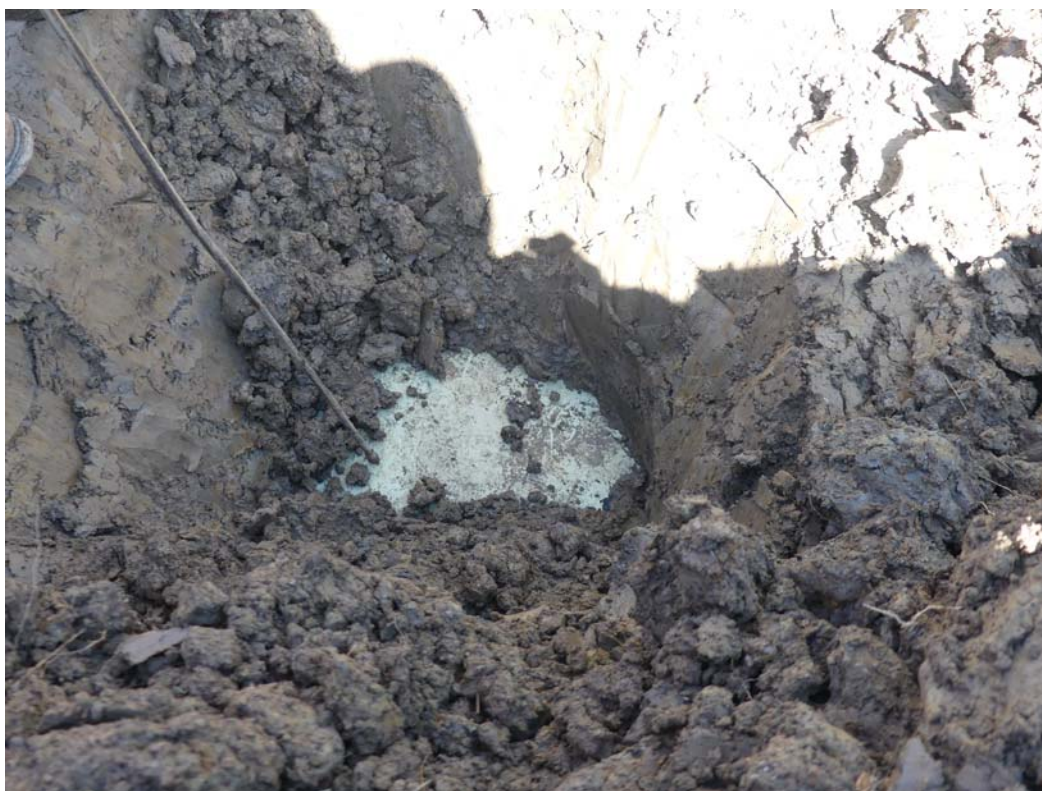
093 - EPOXY COATING FOUND AT INITIAL EXCAVATION - BELL HOLE 1

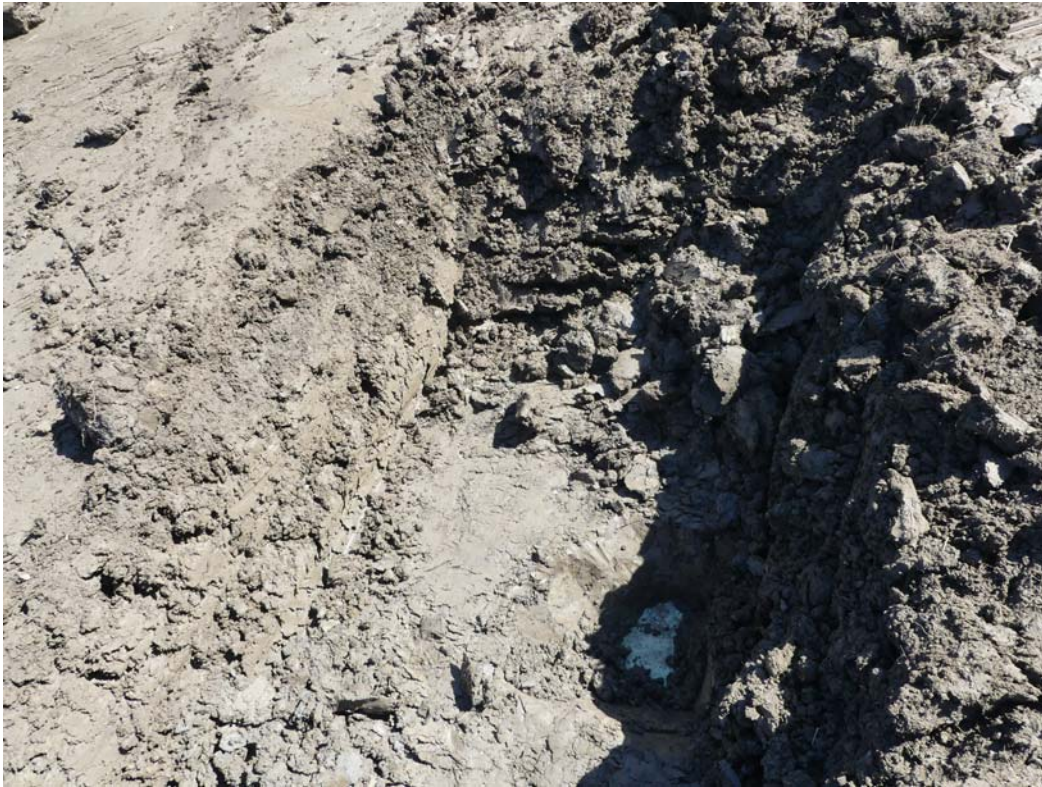
094 - EPOXY COATING FOUND AT INITIAL EXCAVATION - BELL HOLE 2

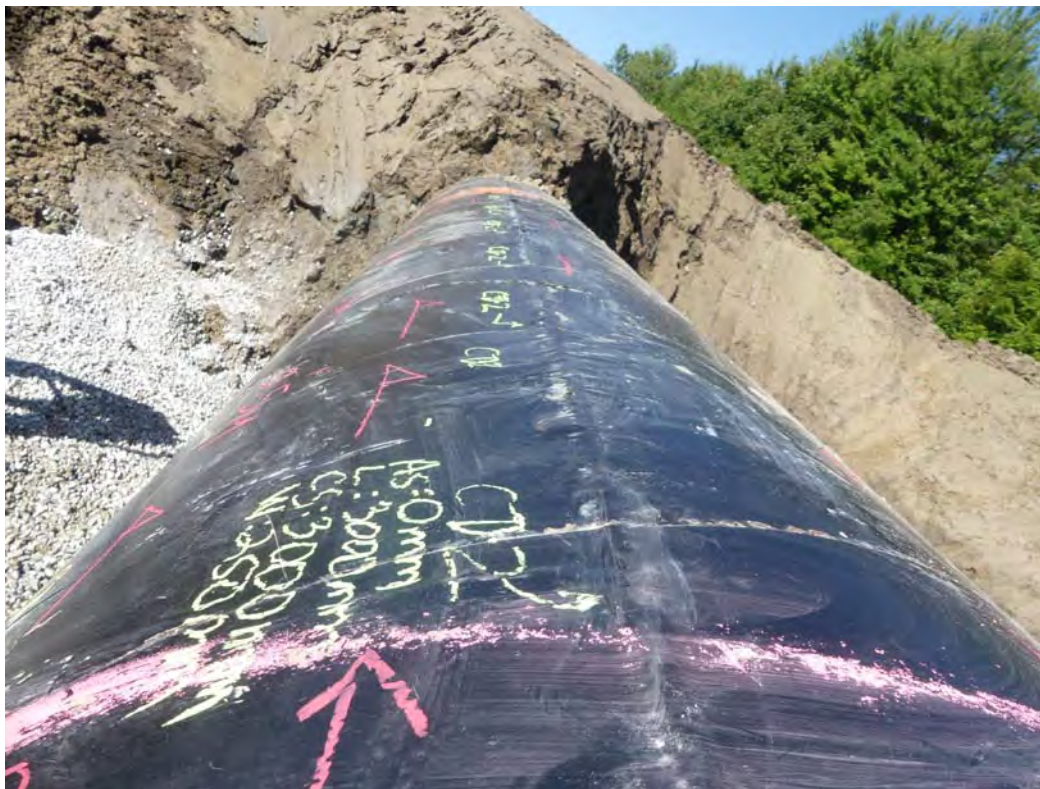
015 - CD-02 OVERVIEW TENTING ALONG LONG SEAM

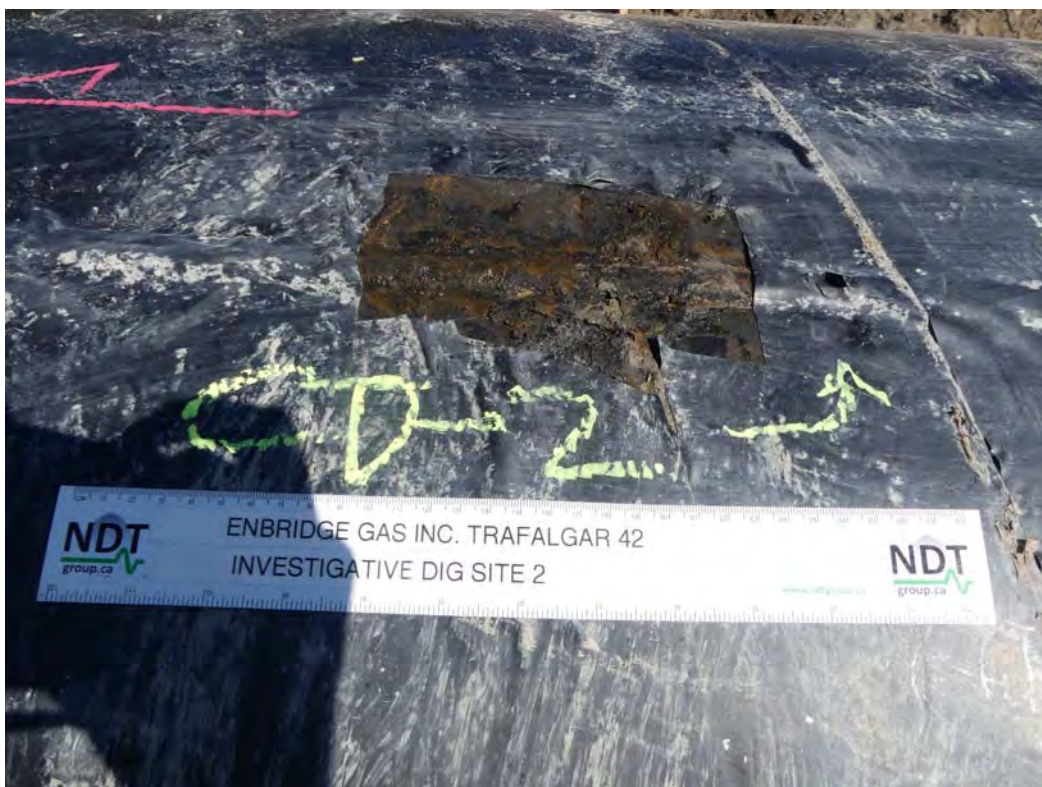
020 - CD-02 COATING REMOVED BLACK CORROSION DEPOSIT

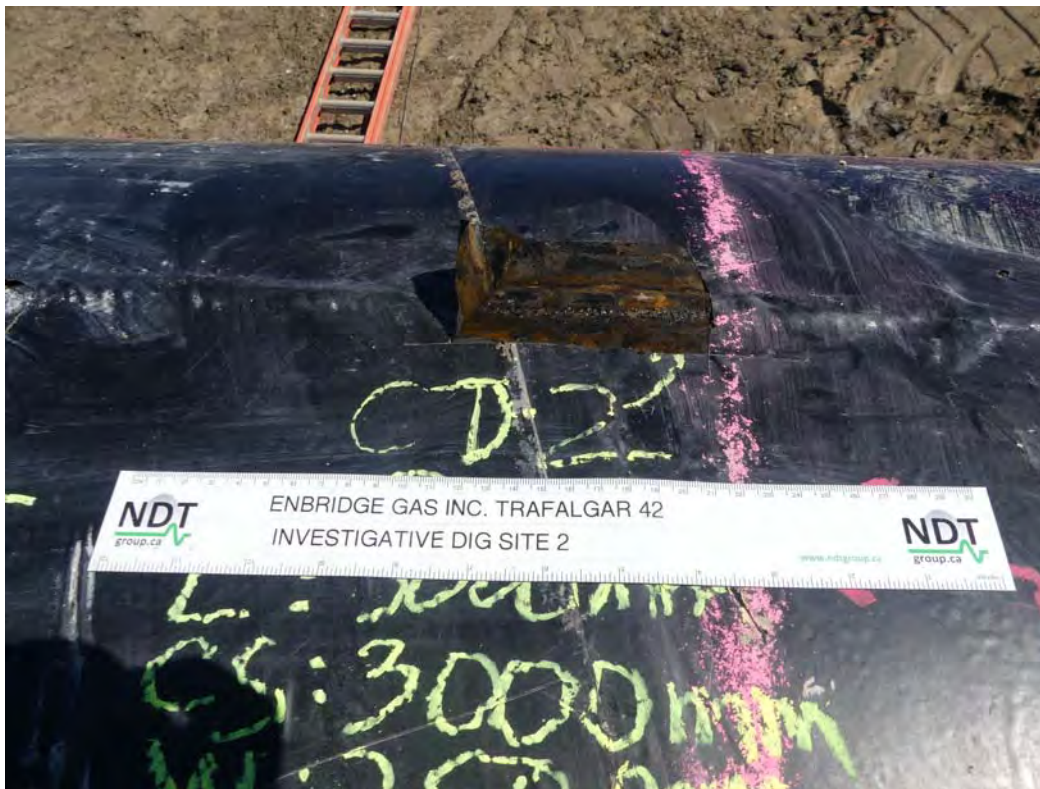
021 - CD-02 COATING REMOVED BLACK, ORANGE CORROSION DEPOSIT

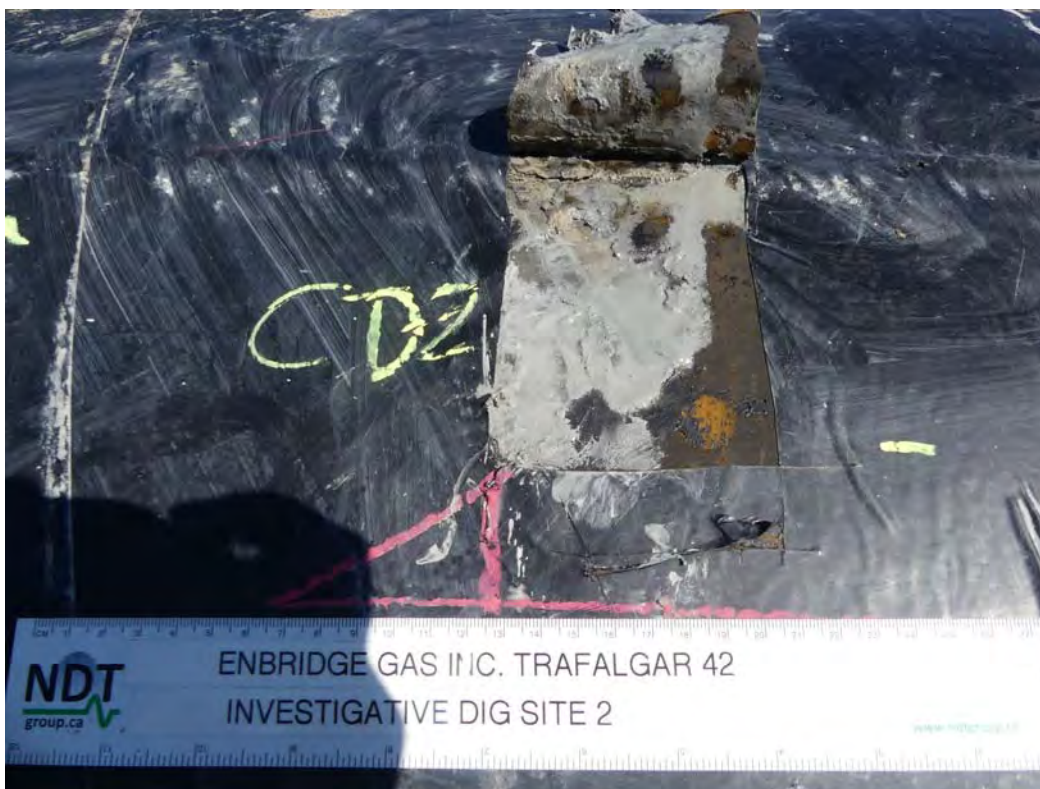
022 - CD-02 COATING REMOVED PASTY GREY CORROSION DEPOSIT CLOSE-UP

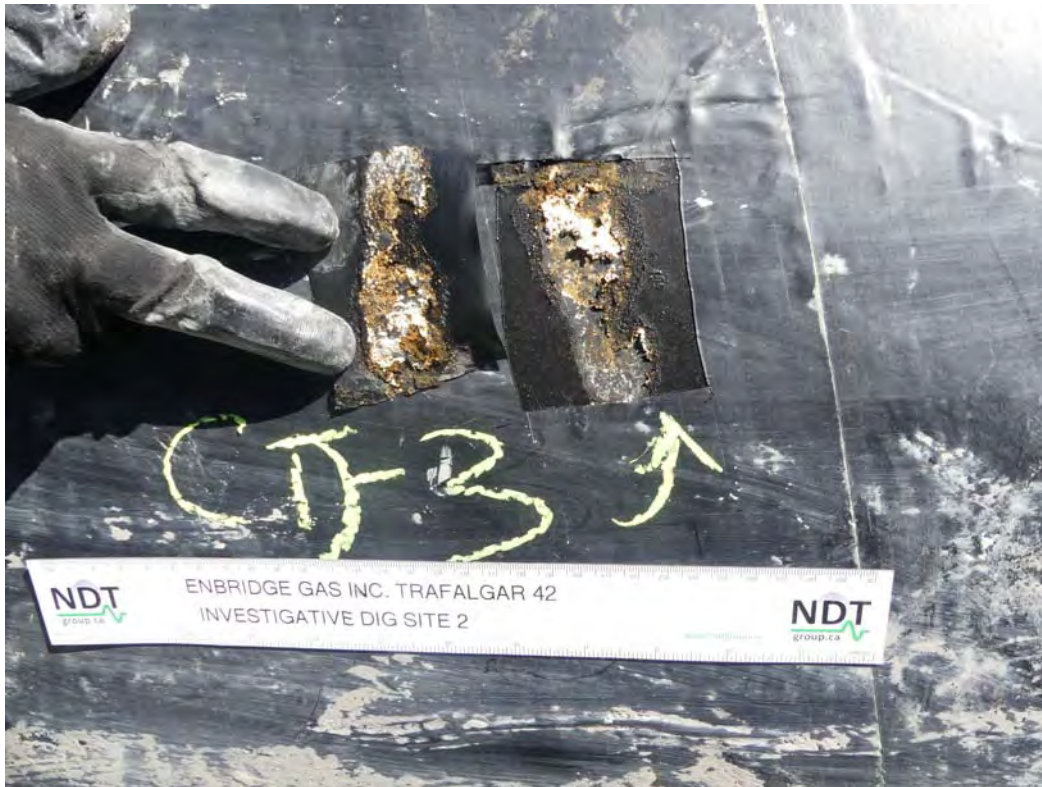
029 - CD-03 COATING REMOVED WHITE, BLACK CORROSION DEPOSIT (1)

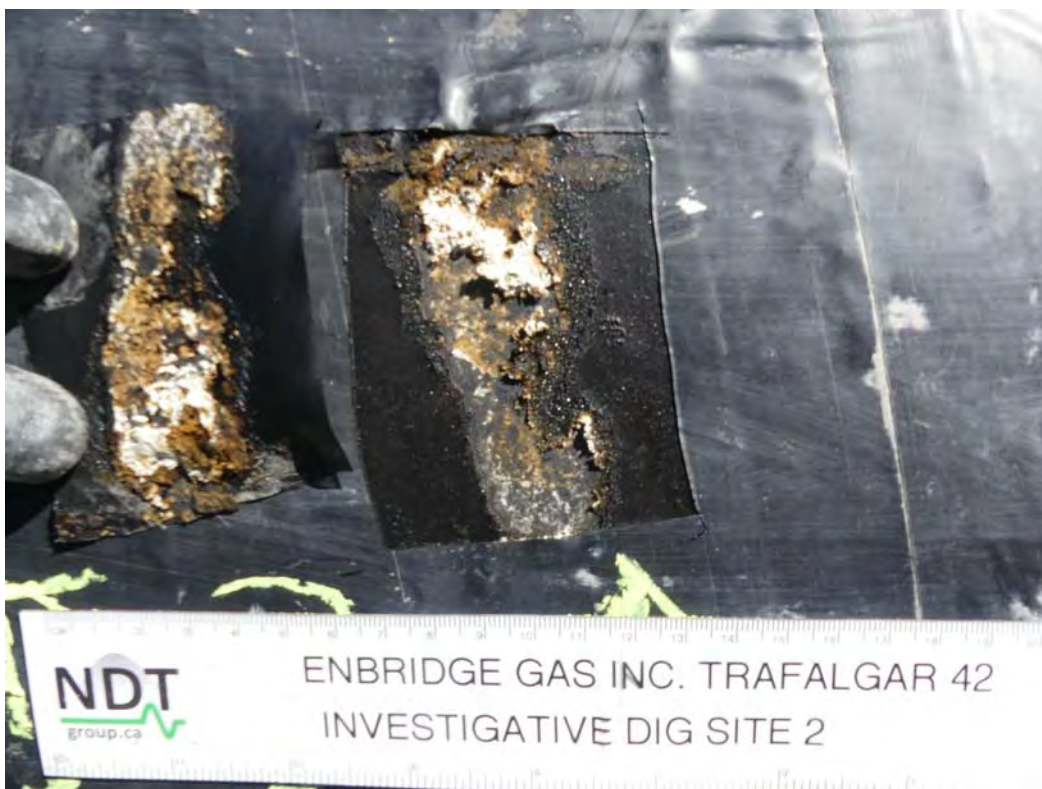
030 - CD-03 COATING REMOVED WHITE, BLACK CORROSION DEPOSIT (2)

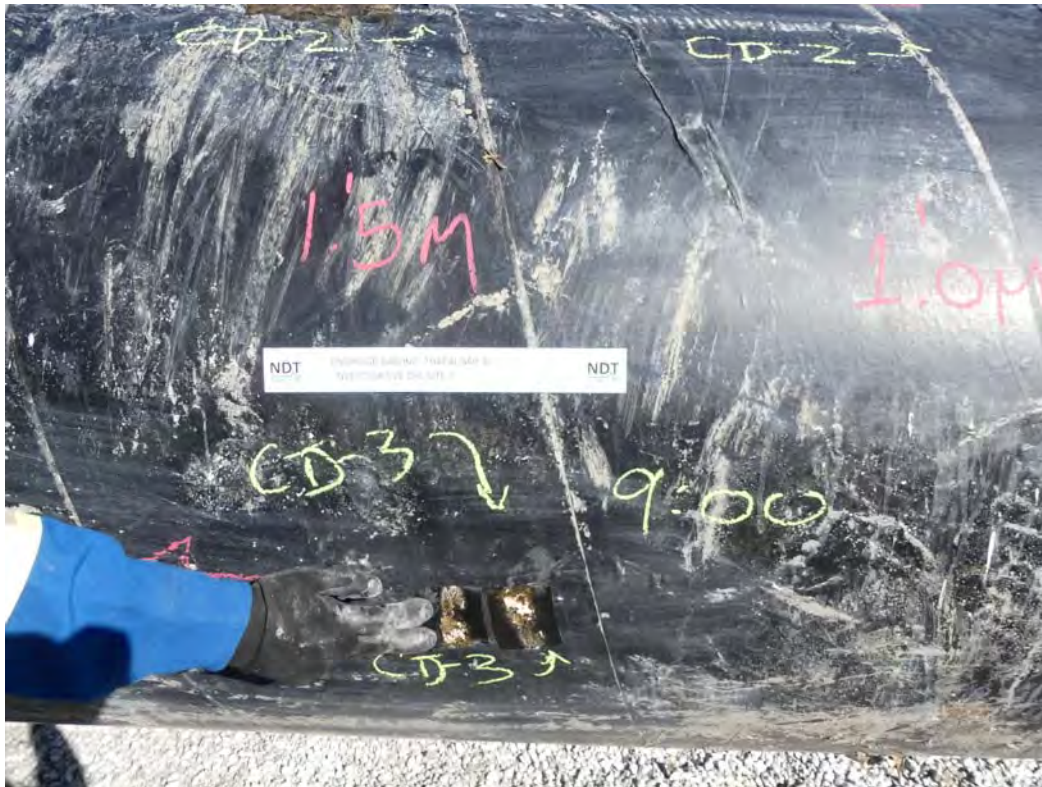
031 - CD-03 COATING REMOVED, CORROSION DEPOSIT AT 1.5 M

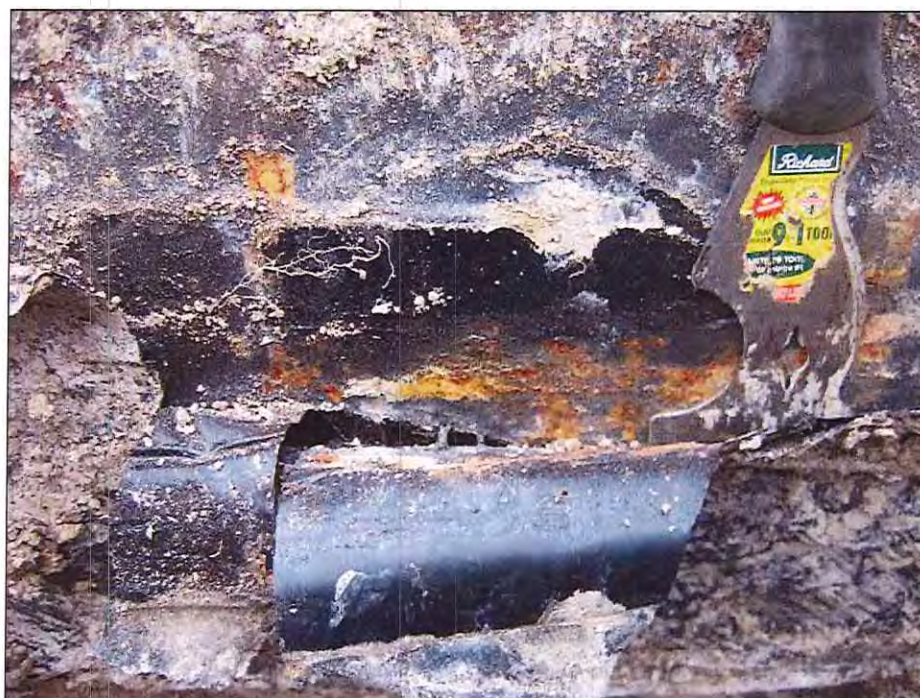
Photograph 4 • Site 1. Sample of Coating Damage. Ch. 69.45 (6.40m).

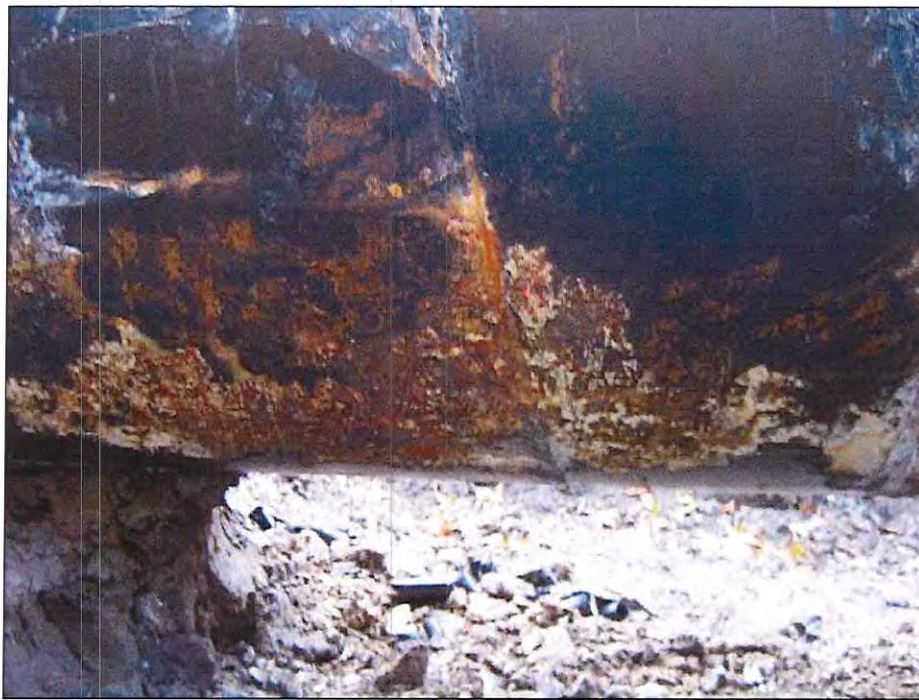
Photograph 7 • Site 1. General Corrosion and Calcareous Deposits.

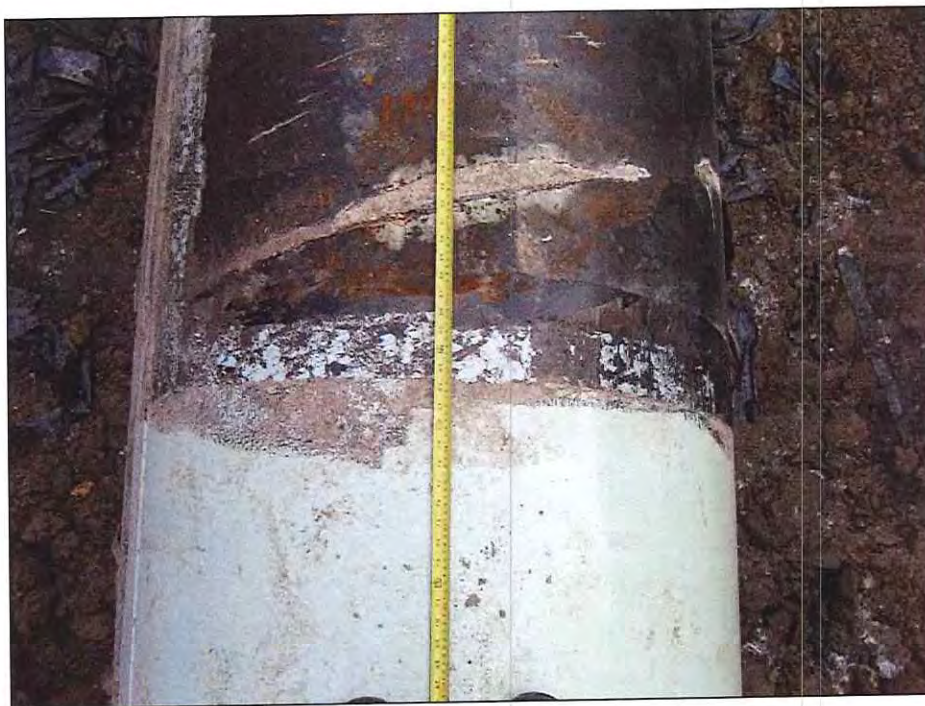
Photograph 9 • Site 1. Pipe Exposed. Corrosion at Overlaps.

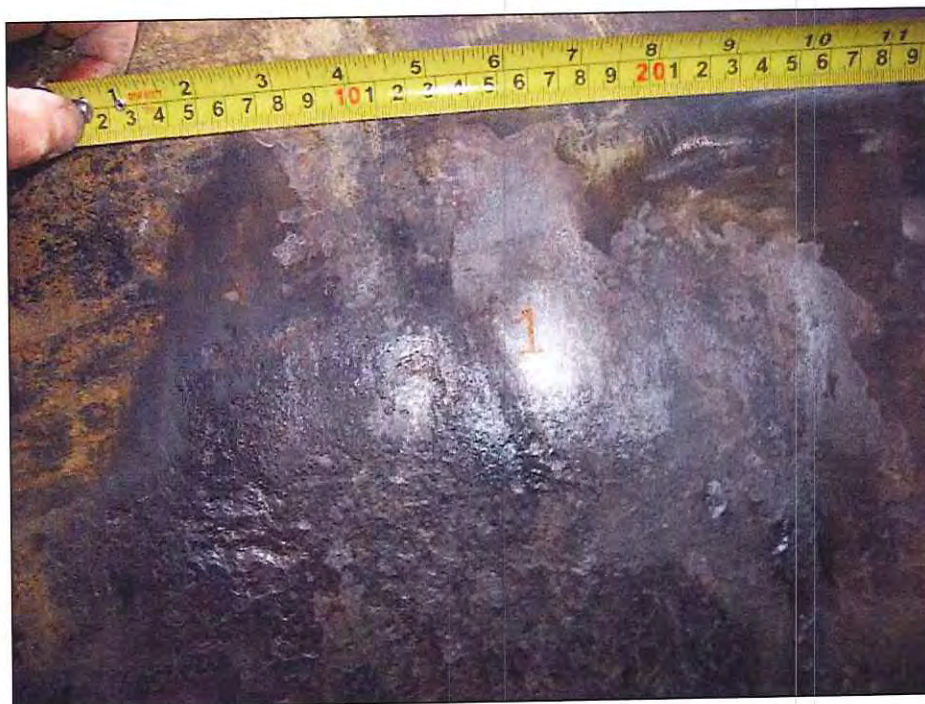
Photograph 10 • Site 1. Pit Cluster #1. Ch. 70.10m (7.05m). General View.

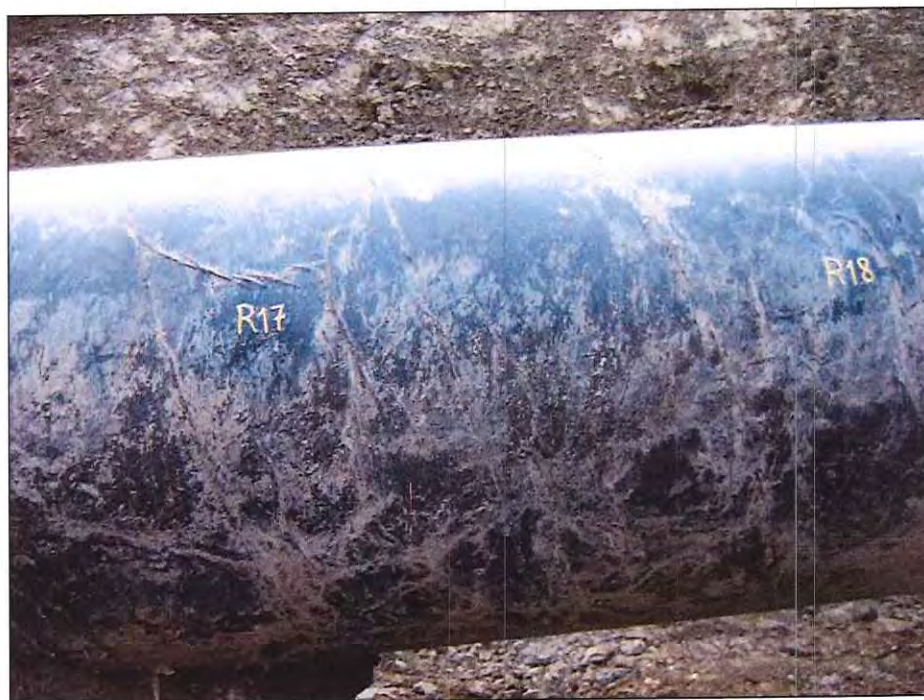
Photograph 13 • Site 2. Disbonded Coating at Longitudinal Weld. Looking South – 03.

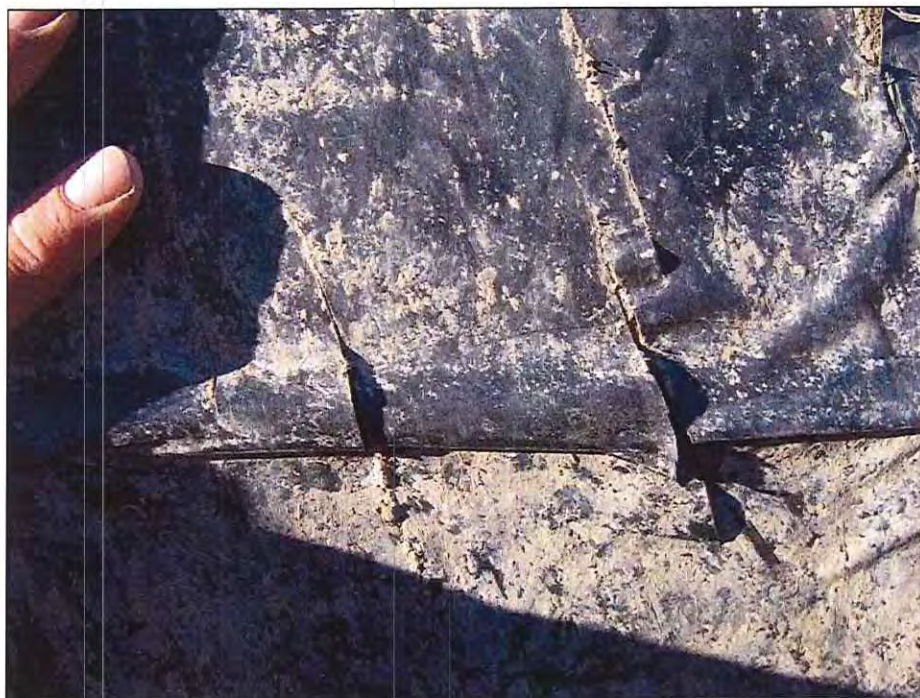
Photograph 20 • Site 2. Coating Damage. Sample of Disbonded Coating (R5).

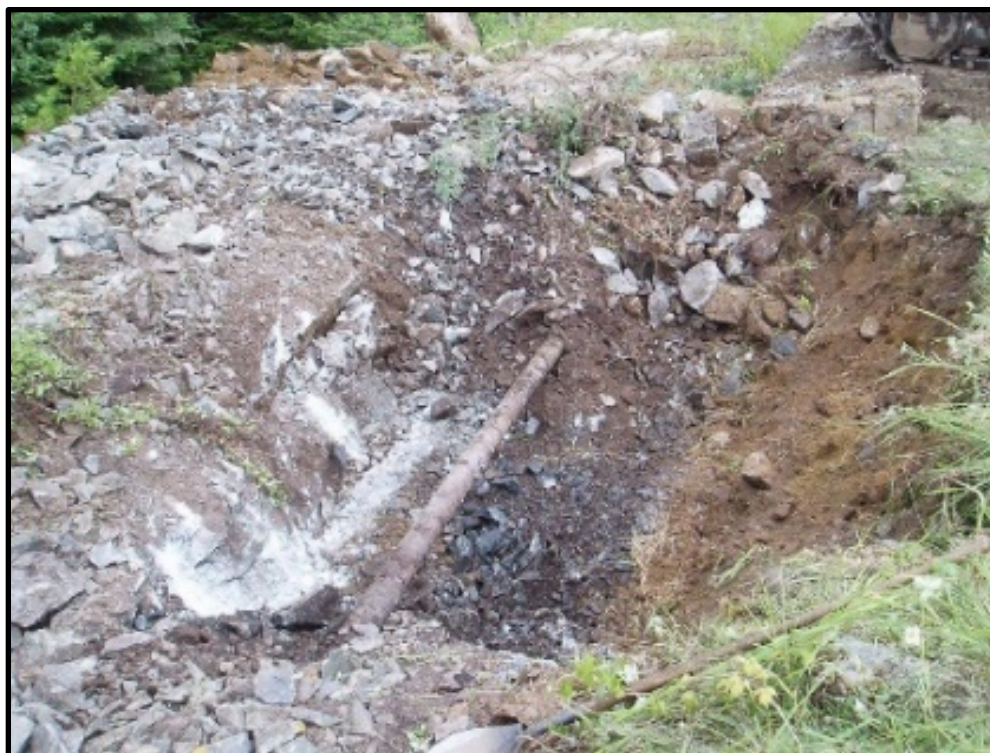
3. The Existing Line was installed in 1958 through a heavily forested region of northern Ontario with areas of very little soil. For much of the length of the Existing Line the pipeline runs through bedrock with blasted main bed and rocky backfill. Backfill has been subject to washouts and erosion, creating an abrasive environment for the pipeline as rock sediment contacts the pipe. Lack of cover for the pipeline is also a concern. Ground conditions for the Existing Line are set out in Figures 1 to 3 below.

Figure 2: Backfill Conditions for the Existing Line

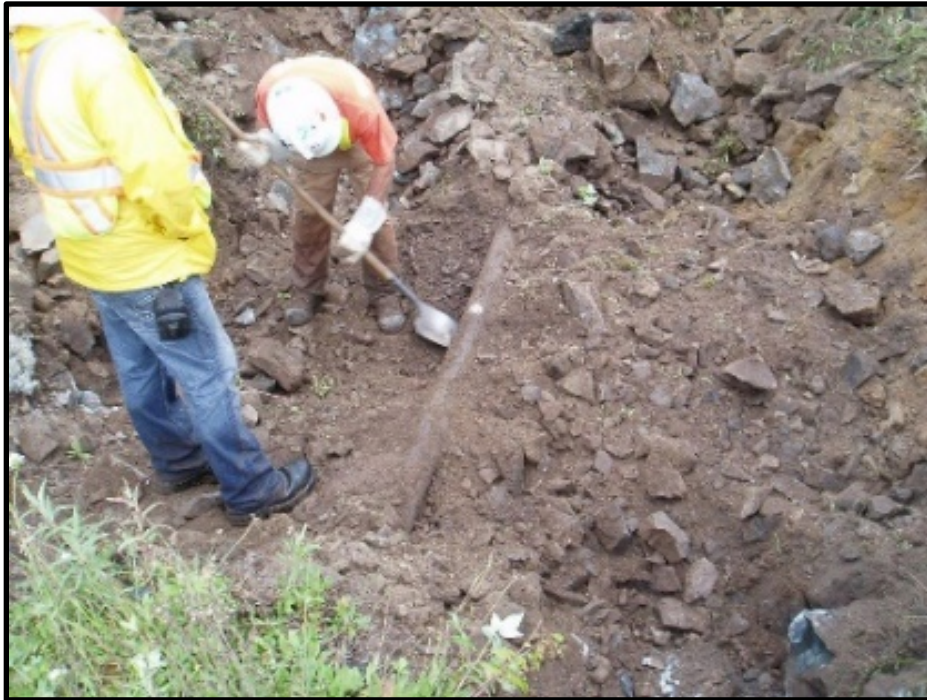
Figure 3: Pipeline Condition for the Existing Line
