**Re: Enbridge Gas Inc. ("Enbridge Gas" or "EGI")  
Ontario Energy Board ("OEB") File No. EB-2021-0148  
2022 Rates (Phase 2) Application and Evidence (Incremental Capital Module)**

This Application (EB-2021-0148) is for Phase 2 of the 2022 Rate Application and addresses matters related to 2022 ICM funding request. With this Application, Enbridge Gas is seeking OEB approval for ICM funding for five projects in 2022 – the St. Laurent Ottawa North Replacement (Phase 3) Project and NPS 20 Replacement Cherry to Bathurst Project in the EGD rate zone, and the Dawn to Cuthbert Replacement and Retrofits Project, Byron Transmission Station Project and Kirkland Lake Lateral Replacement Project in Union rate zones. The ICM evidence including the appendices are filed as Exhibit B, Tab 2, Schedule 1.

45. Enbridge Gas has identified the need to replace approximately 650 m of the existing NPS 42 Dawn to Cuthbert pipeline to mitigate pipeline integrity concerns in the Township of Dawn-Euphemia, in the County of Lambton, Ontario. The project is a like-for-like replacement of pipeline and does not require Leave to Construct approval. The NPS 42 Dawn to Cuthbert pipeline supplies the NPS 42 Dawn to

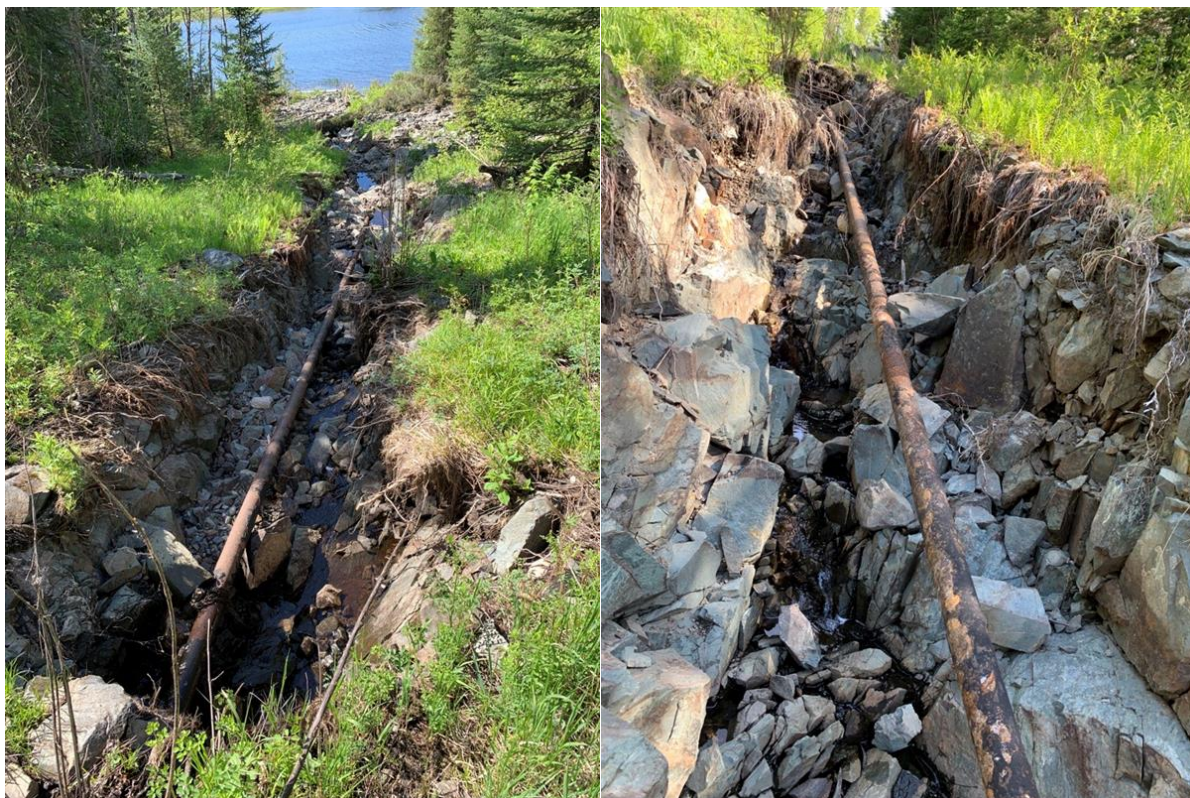
Figure 4: Washout of the Existing Line
